BIT's 3rd International Congress of Environment-2013

Long-term effects and remediation after a major nuclear accident

Rolf Sjöblom

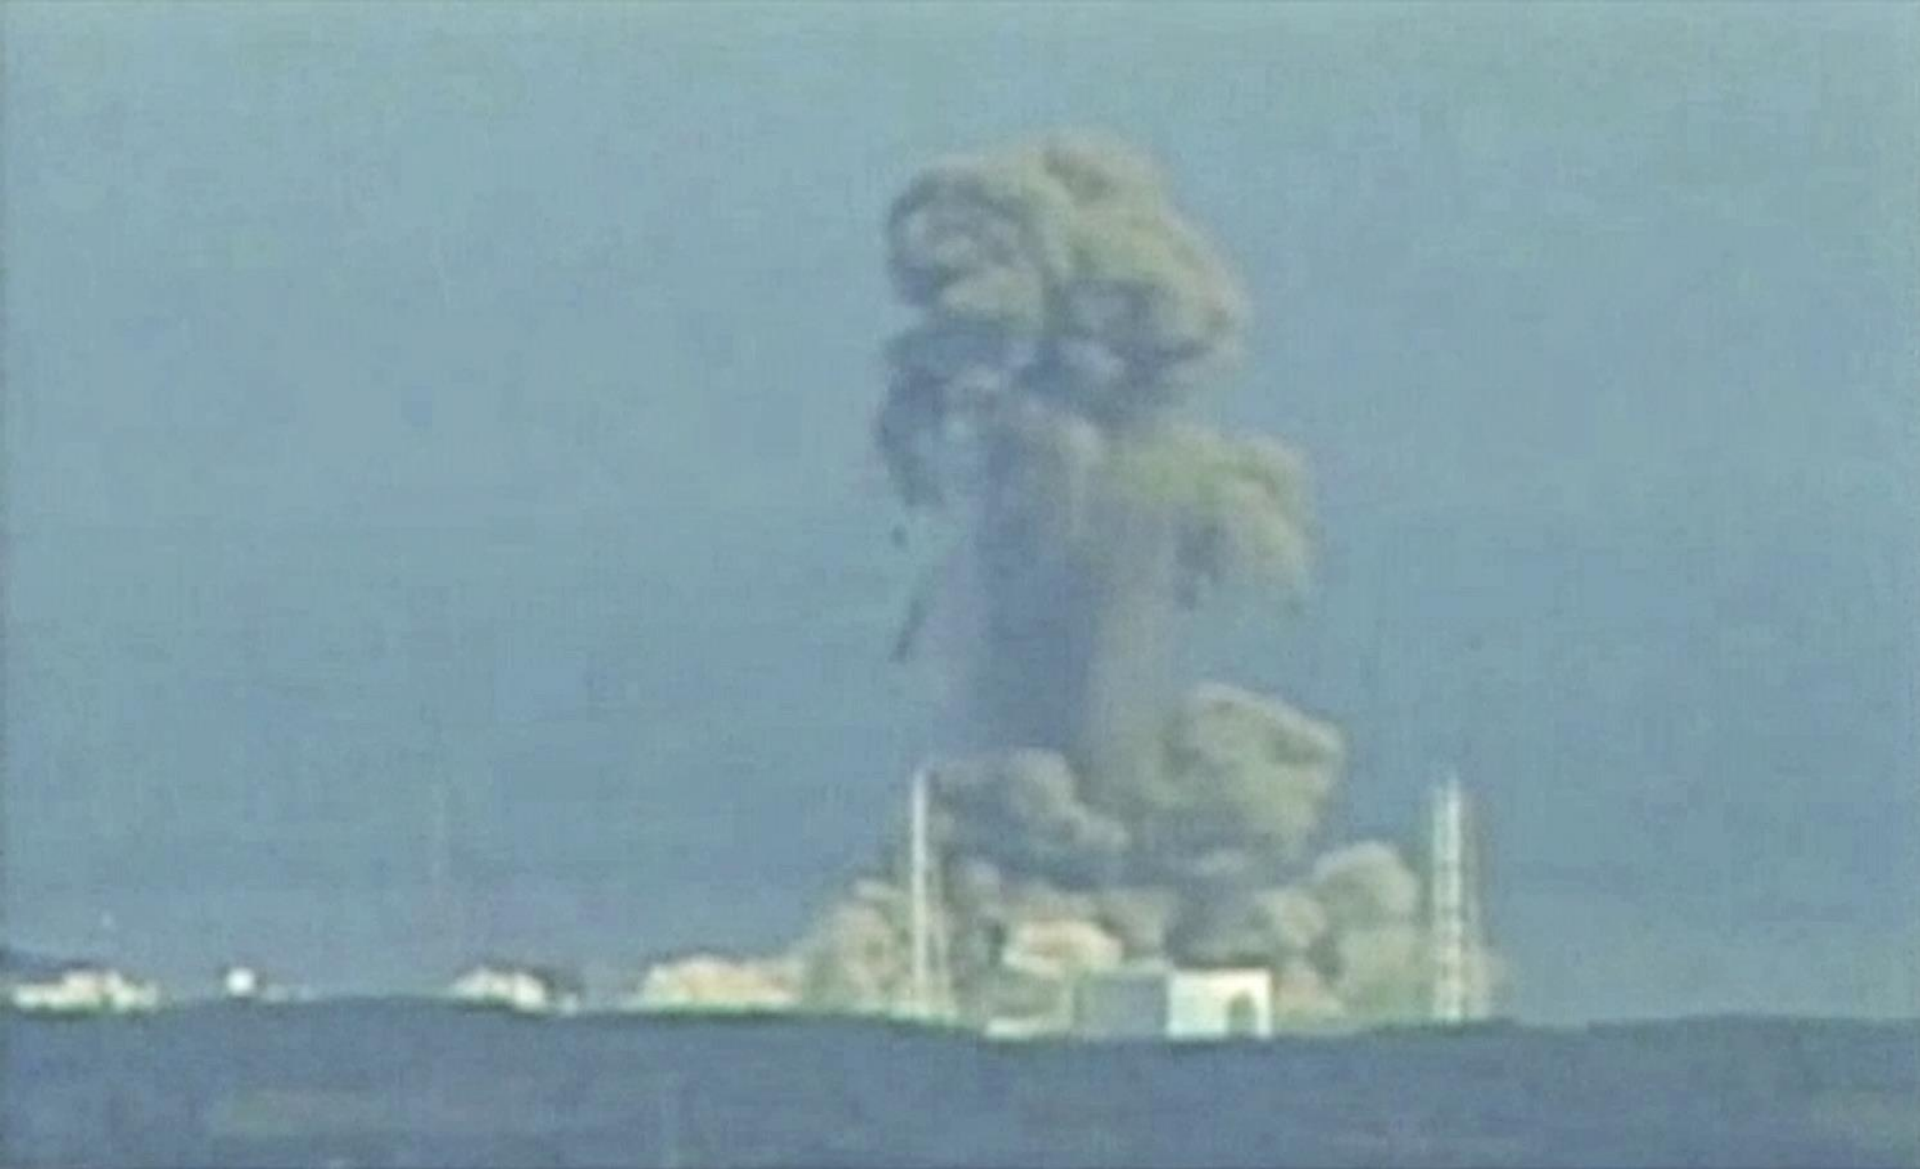
Gas explosion in a reactor building

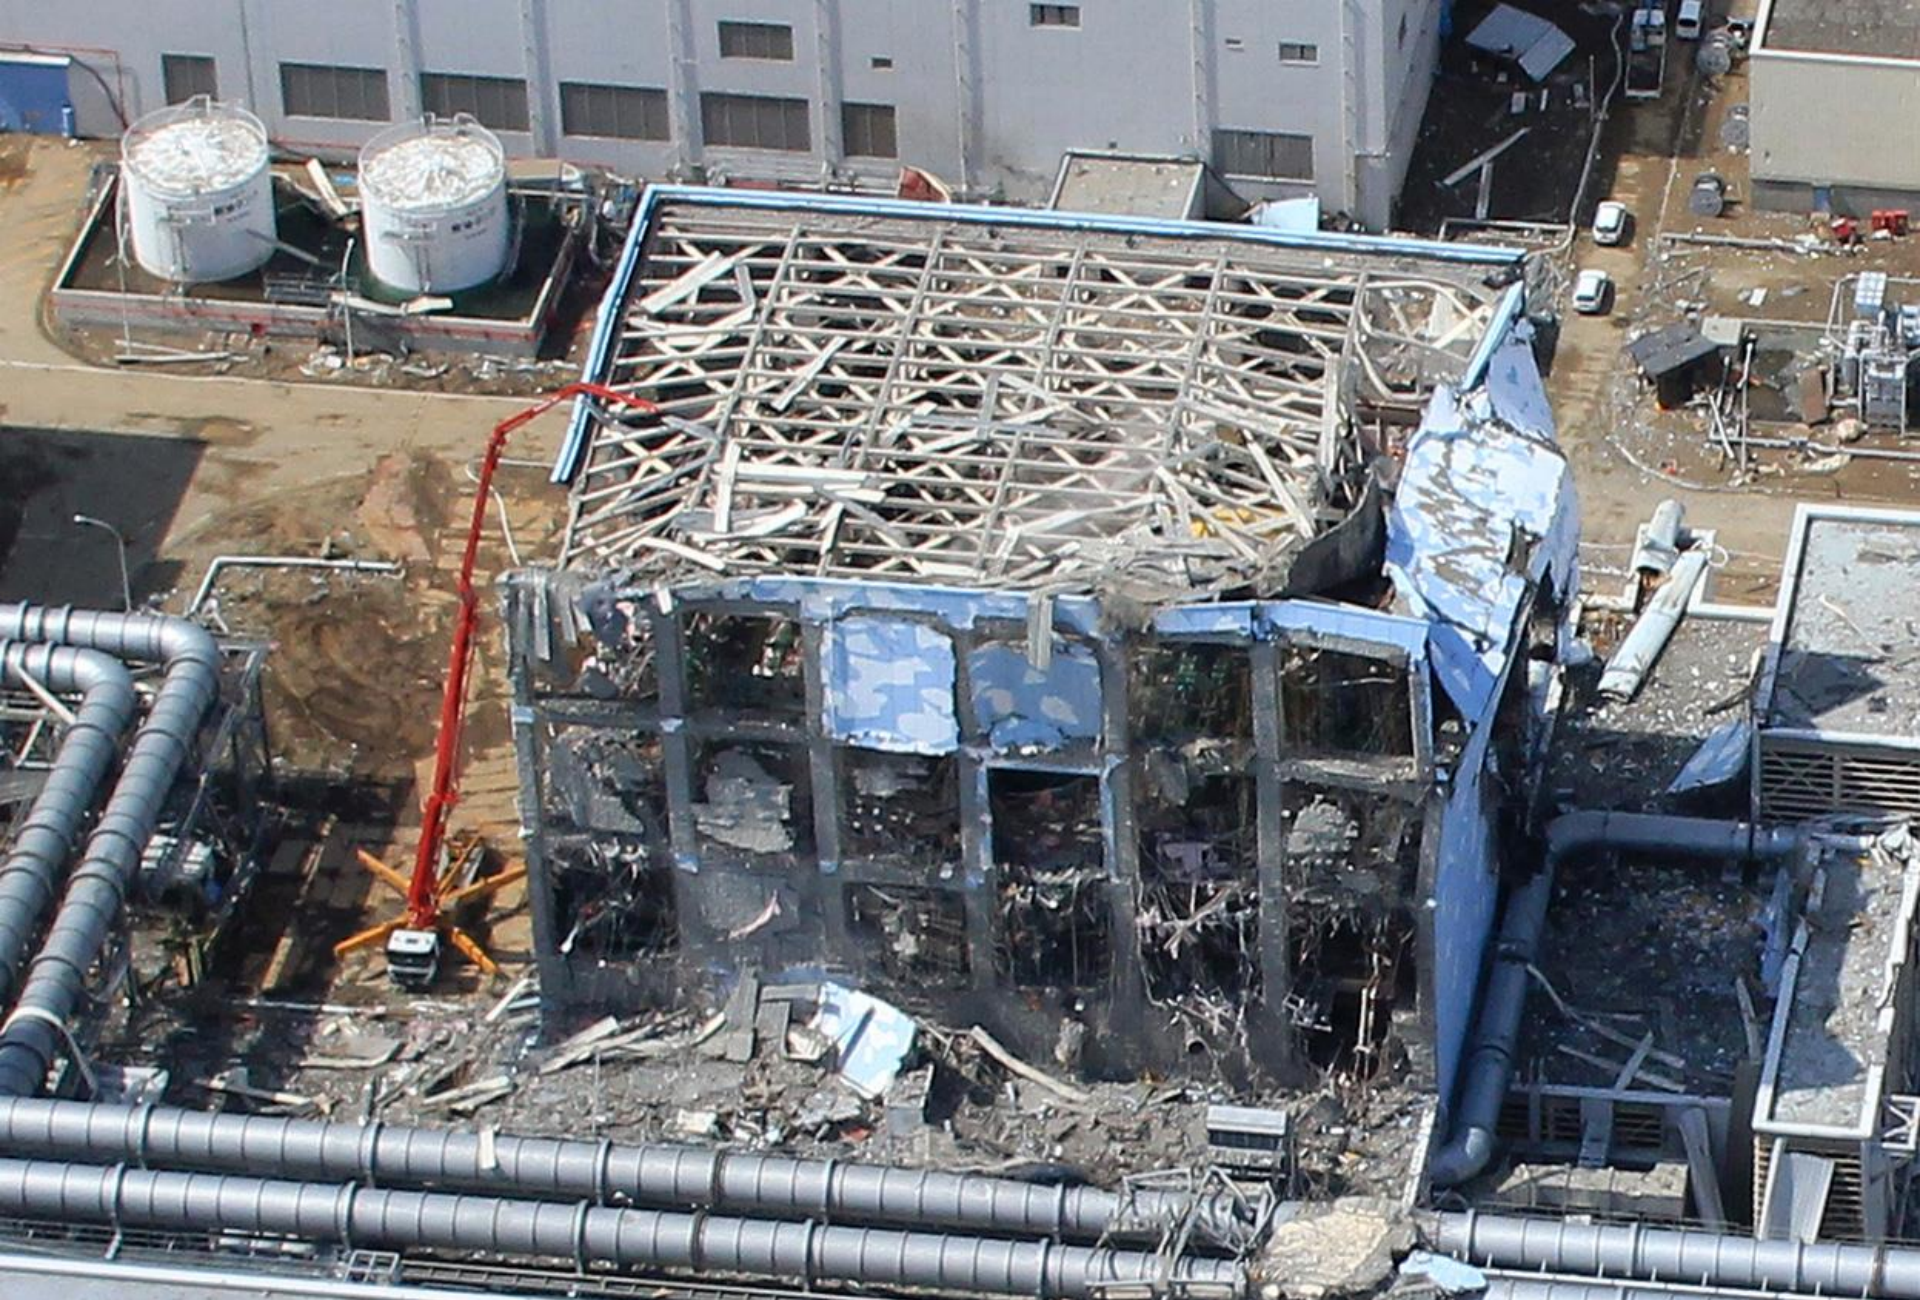
Reactor building after gas explosion
